## Knocking off fragments of damaged stone as a preventive measure? The case of rusticated masonry at the Dreilinden estate in Lucerne

Per Storemyr and Christine Bläuer  
CSC Conservation Science Consulting Sàrl  
Fribourg, Switzerland

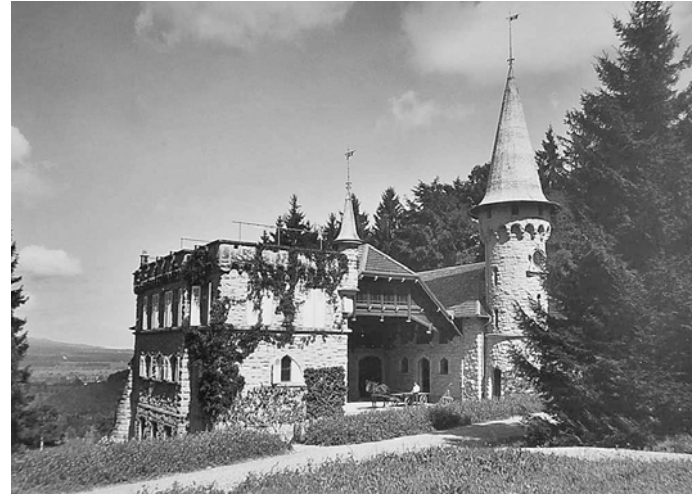
The "economy building", originally the stables of the Dreilinden estate in 1926, seen from the south. Photo: Fotograf Gustaedt. Stadtarchiv Lucerne.

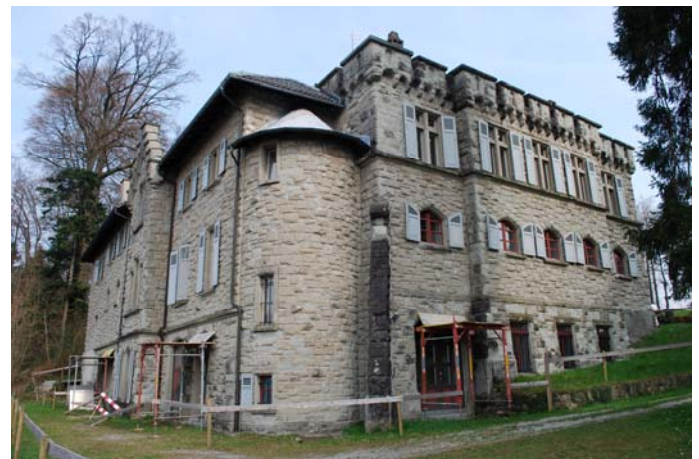
The "economy building" seen from the west with its two largest and most damaged walls in 2009. Lighter stones had their surfaces knocked off mainly in 2005 and 2006.

A potential safety problem was thus (at least temporarily) solved, but new problems were simultaneously introduced. First, a most significant stylistic trait of the building – the rustication – was impacted on by the creation of large, "flat" façade parts. Second, options for future conservation were effectively reduced. It is now possible to leave the knocked-off areas as they appear, to remodel using mortar or to replace fragments and entire stones with new ones. The important option of fixing partially loose fragments is, obviously, not feasible anymore. Third, dependent on future conservation concept (yet to be developed), repairs may become more expensive than as compared to a situation in which the hundreds of fragments posing no or extremely low risk to passers-by had been left on the building.

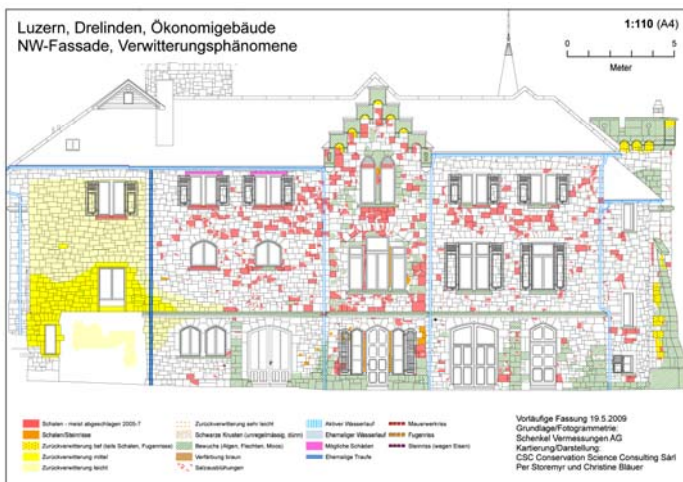
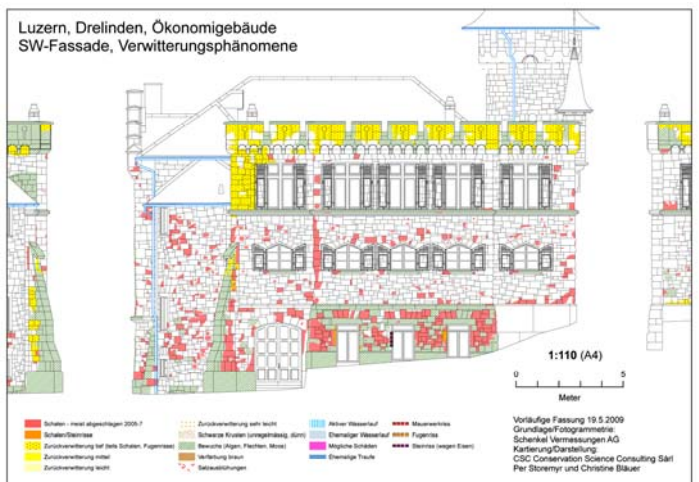
Below: Maps of weathering phenomena at the NW and SW façades. Knocked-off stone fragments are marked with red. Maps produced using GIS.

Very few damages can be observed on photos from 1926 and 1975, yet it is likely that minute scales and fissures started to develop relatively early. Though no close calls have been recorded, by the mid 1990s it was believed that partially loose stone fragments, some of which had already fallen off, presented a risk to passers-by. A programme of knocking off pieces started and was intensified by 2005. Perhaps as a result of the slightly more hazardous situation at the nearby main building of the estate, at this stage the programme involved removing virtually every stone surface displaying scales and fissures, whether posing a risk to passers-by or not. More than 1000 stones at the two most exposed façades were affected. They lost 40 m<sup>2</sup> or almost 10% of their surface.
