# WEATHERING OF NATURAL BUILDING STONES

Materials and conservation of built cultural heritage – The weathering of the natural building stones – BR 4

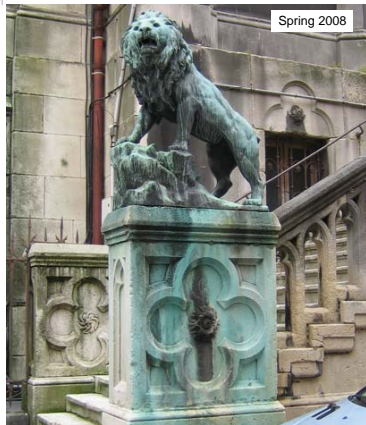
### Stains

Nancy Cathedral  
(France)  
Limestone

- Generally correlated with alien materials like: rust (*rouille*), copper salts (*sels de cuivre*), organic substances, painting, varnish...
- This phenomenon does not strictly depend on exposure conditions of water supplies.

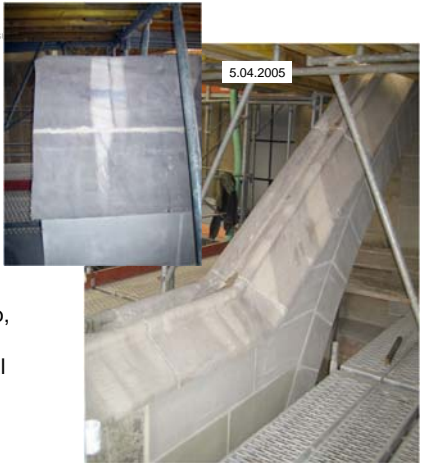
#### Discolouration

A flying buttress top, south façade, Lausanne cathedral Arvel Limestone

- The original colour of a material changes because of processes like:
  - water penetration (more or less permanent coloured stains);
  - exposure to sunlight (fading);
  - formation of metallic oxide in the structure; ...but not because of a deposit.
- Does not depend on exposure conditions to water supplies.

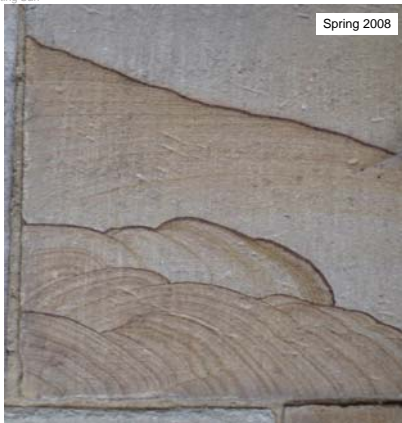
#### Discolouration

Epinal Basilica (France) sandstone

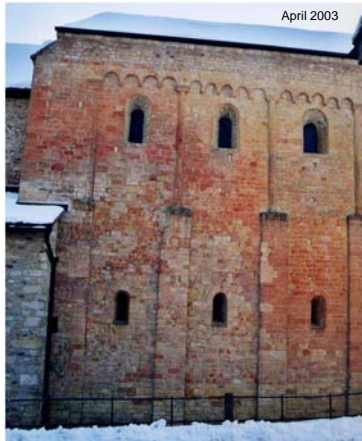
#### Red staining

Abbey church  
Romainmôtier (CH, VD)  
Pierre jaune  
from Neuchâtel

- Chromatic alteration due to **local** oxidation of iron components on the stone surface often caused by a **fire**.
- This phenomenon **does not depend on weather exposure conditions**.

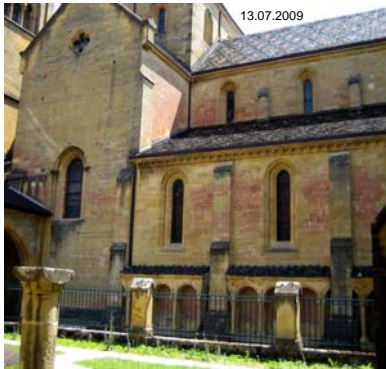
#### Red staining

Collegiate church  
Neuchâtel(CH, NE)  
Pierre jaune  
from Neuchâtel

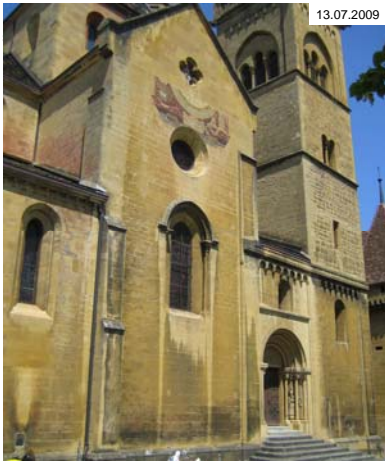
#### Patina

Collegiate church  
Neuchâtel (CH, NE)  
Pierre jaune  
from Neuchâtel

- Black, brown, ocher, yellow
- Natural modifications of the building stones surface = normal “ageing” in outdoor environment
- Quite uniform very thin layer which sticks to the substrate from which it is chemically different (enriched in iron/clay minerals and/or in biogenetic calcium oxalates). Origin of the patina materials: endogenous (calcite, salts) and exogenous (soots, dust, micro-organisms, salts)
- Physical and colour modification but do not lead to a deterioration
- Can gradually evolve to the formation of crusts
- Usually take place in **the zones protected from water supplies**

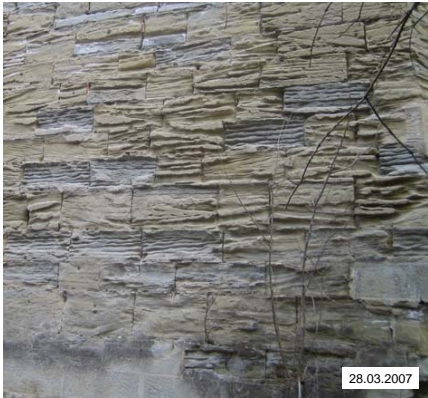
### Differential erosion

A city wall of Fribourg (CH, FR)  
Burdigalian Molasse sandstone

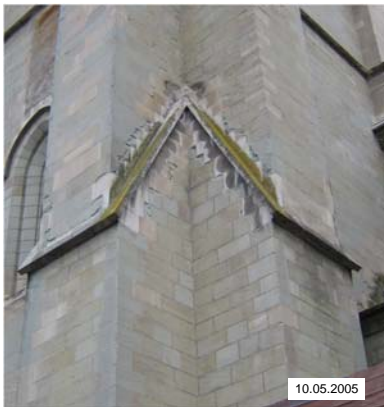
### Differential erosion

Bell tower, south side, Lausanne cathedral (CH, VD)  
burdigalian molasse sandstone

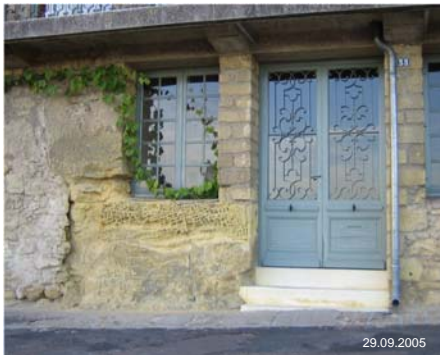
### Alveolization

Chinon  
(France,  
Loire Valley)  
Tuffeau stone

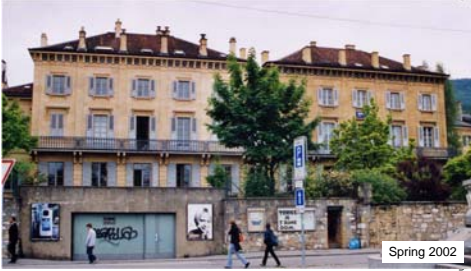
### Anthropogen erosion

Neuchâtel  
(CH, NE)  
Pierre jaune  
from Neuchâtel

- More or less harmful erosion provoked by cleanings
- According to the chosen process of cleaning, erosion will be mechanical and/or chemical
- Does not strictly depend on the exposure conditions.

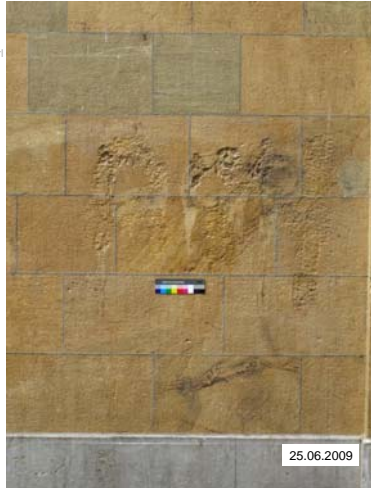
### Anthropogen erosion

Neuchâtel  
(CH, NE)  
Pierre jaune  
from Neuchâtel

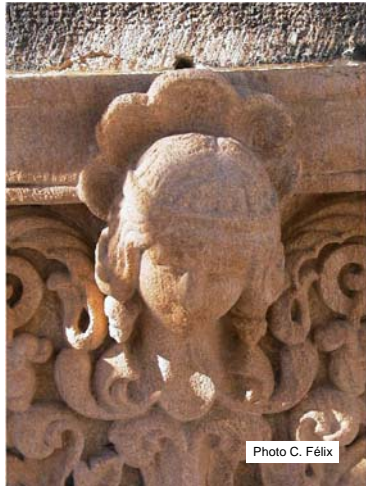
### Anthropogen erosion

Natural History  
Museum of  
Neuchâtel (CH, NE)  
Pierre jaune of  
Neuchâtel

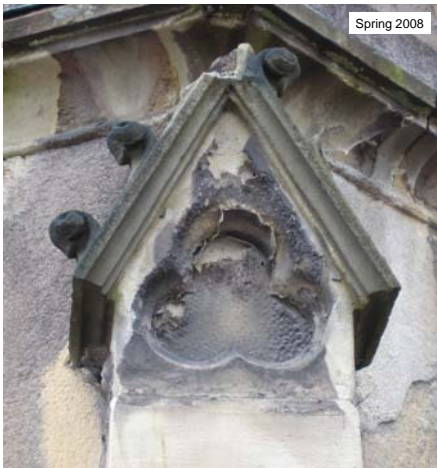
#### Crust

Epinal Basilica  
(France)  
Sandstone

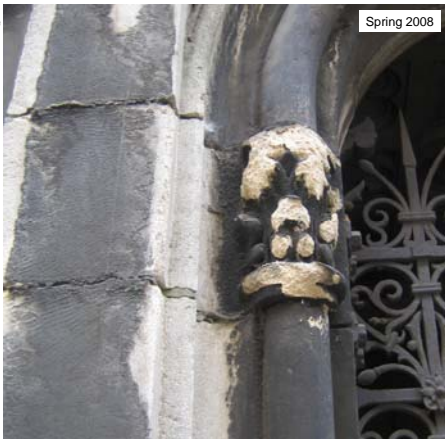
#### Crust

(Nancy, France)  
Savonnières limestone

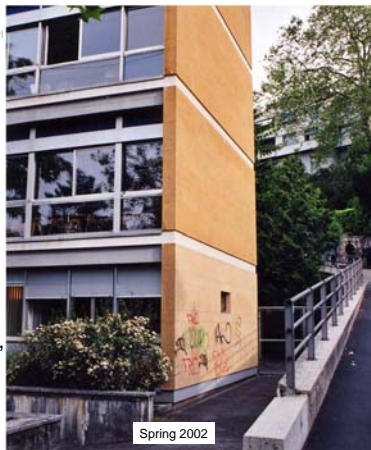
#### Film (antigraffiti)

D. de Rougemont Lycée,  
Neuchâtel (CH, NE)  
Jaumont limestone

- Very thin covering or coating layer, usually homogeneous and of organic nature
- More or less easy to remove it from the substrate
- Does not strictly depend on the exposure conditions to water supplies.

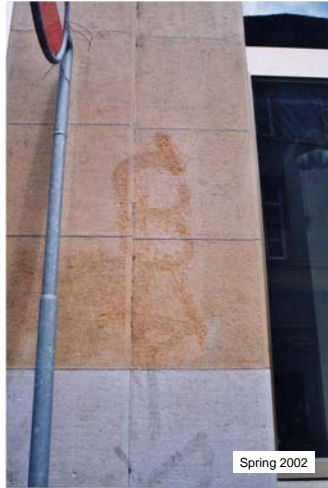
#### Film (antigraffiti)

Neuchâtel (CH, NE)  
Pierre jaune  
from Neuchâtel

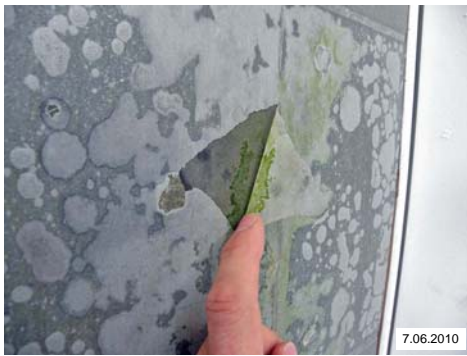
#### Film (antigraffiti)

Geneva (CH, GE)  
(photo O. Fawer)

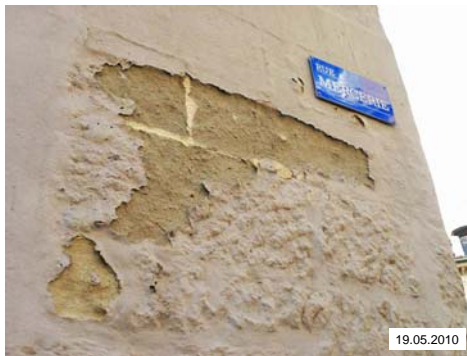
#### Film (paint layer)

Lausanne (CH, VD)  
(photo O. Fawer)

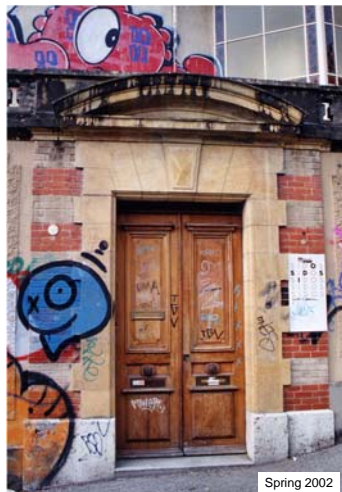
#### Graffiti

Ruelle Vaucher  
Neuchâtel (CH, NE)  
Pierre jaune from  
Neuchâtel, bricks &  
rendering (*crépi*)

- Results from the engraving, scratching or application of paint, ink or similar matter on the stone surface
- This phenomenon **does not depend on the exposure conditions to water supplies.**

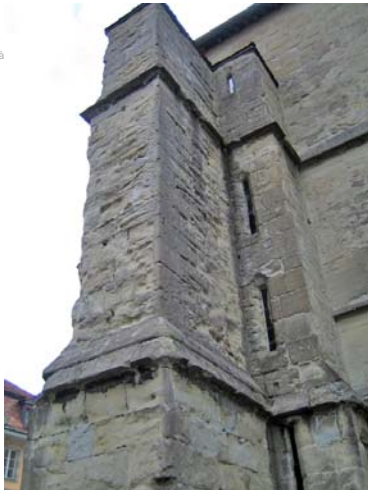
#### Granular disintegration

Bell tower, west Lausanne Cathedral (CH, VD) Aquitanian molasse sandstone

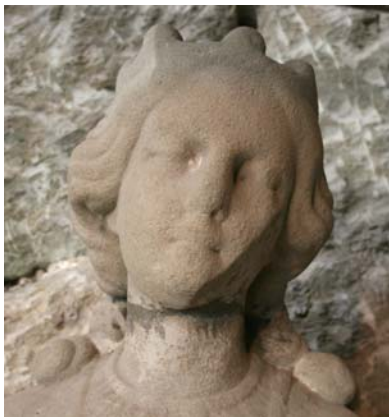
#### Granular disintegration

Musée d'Art et d'Histoire Fribourg (CH, FR) Statue from the south cathedral portal Burdigalian molasse sandstone

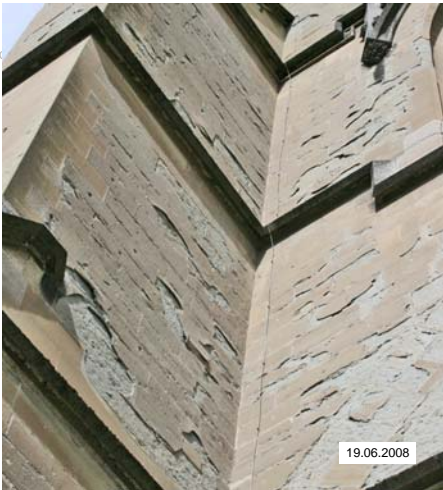
### Contour scaling

Fribourg  
Cathedral  
(CH, FR)  
Burdigalian  
molasse  
sandstone

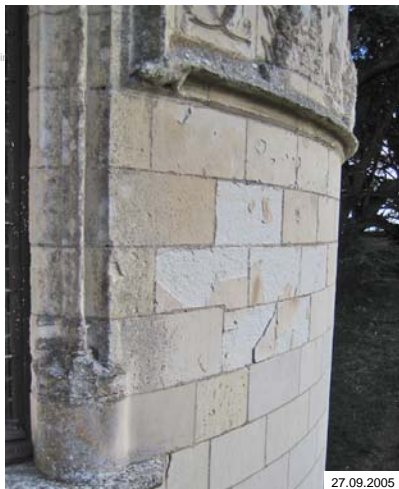
### Contour scaling

Chaumont castel  
France, Loire Valley  
Tuffeau stone

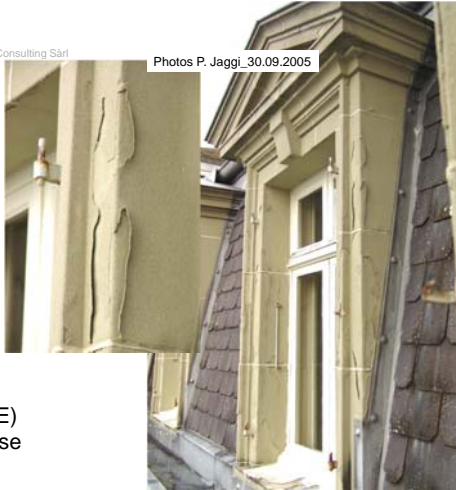
Contour  
scaling  
(because of  
water  
repellent)

Rue de l'Evole  
Neuchâtel (CH, NE)  
Burdigalian molasse  
sandstone

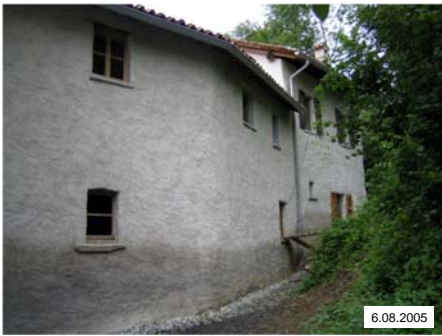
#### Damp patches

Ballenberg museum (CH, BE) (farmhouse from Tessin)

- The material surface shows wet spots or zones of different color, generally darker
- Can be caused for example by the penetration of water (by rising damp) and/or by the hygroscopic behaviour of salt.

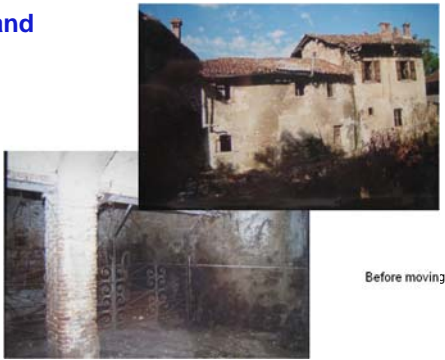
#### Damp patches

Ballenberg museum (CH, BE) (farmhouse from Tessin)

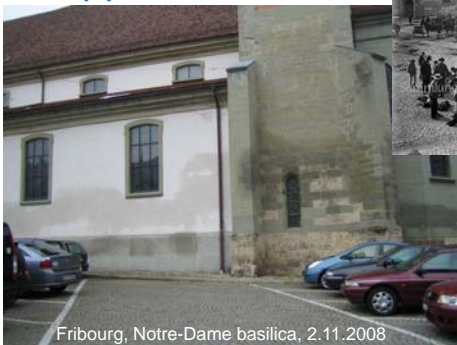
#### Damp patches

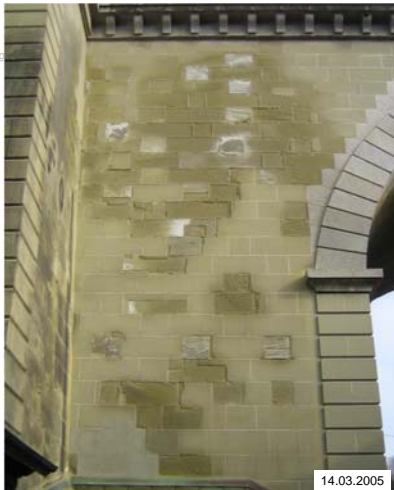
#### Damp patches + efflorescences

Berne (CH, BE)  
Nydegg bridge, south side  
Burdigalian molasse sandstone

- **Subflorescence:** accumulation of salt crystals just under the external surface of building stones. They are HARMFUL: the pressure exerted by crystals can cause damages
- **Efflorescence:** any visible salt deposit on the surface of the building stones (=> LESS HARMFUL) (washed by every water supply)
- **Caused by the salt concentration and precipitation in the water evaporation zones**

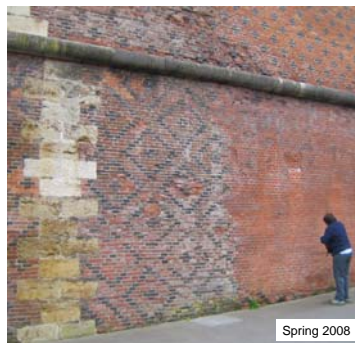
#### Efflorescences

City wall of Nancy (France)  
Bricks

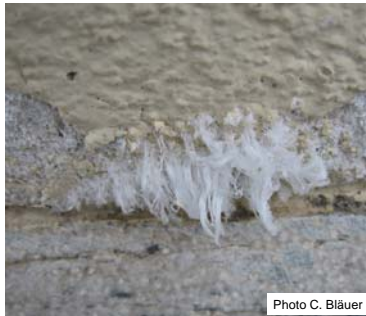
### Efflorescences

Chur  
(CH, GR)

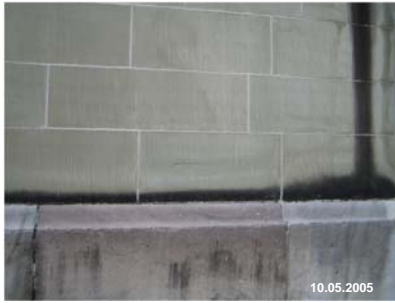
#### Algae

Lausanne  
Cathedral (CH, VD)  
Border between  
burdigalian molasse  
sandstone and  
the dense  
Arvel limestone

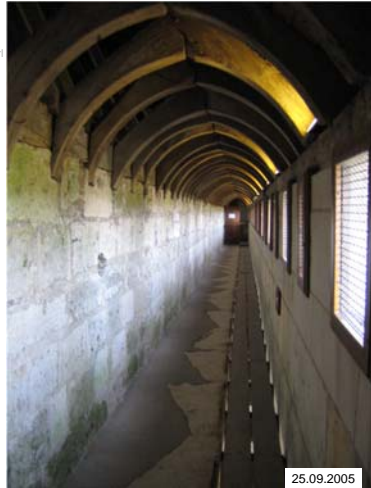
#### Algae

Sully-sur-Loire castel  
France, Loire Valley  
Tuffeau stone

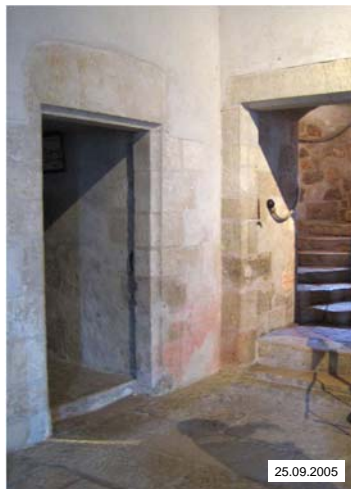
#### Algae or bacteria

Sully-sur-Loire castel  
France, Loire Valley  
Tuffeau stone

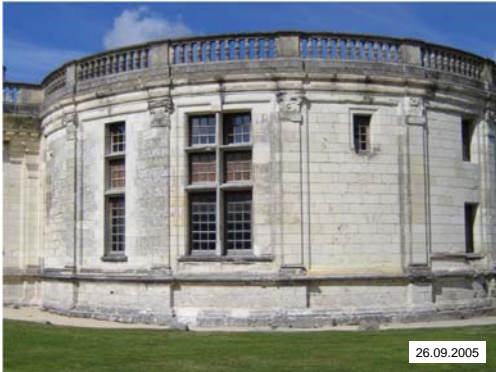
### Algae

Chambord  
castel  
France,  
Loire  
Valley  
Tuffeau  
stone

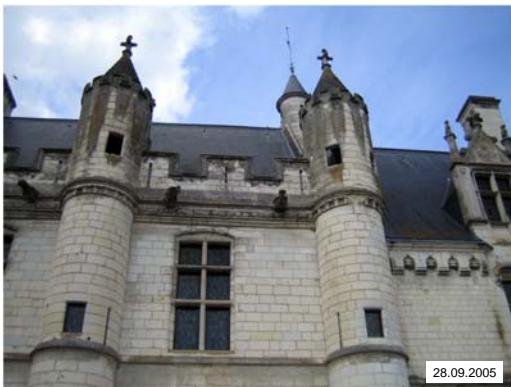
### Algae, lichen

Loches  
castel,  
France,  
Loire  
Valley,  
Tuffeau  
stone

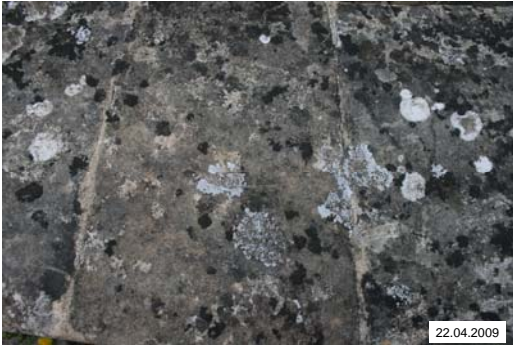
**Algae,  
lichen,  
mosses**

Neuchâtel  
Hôtel  
du Peyrou  
(CH, NE)  
limestone

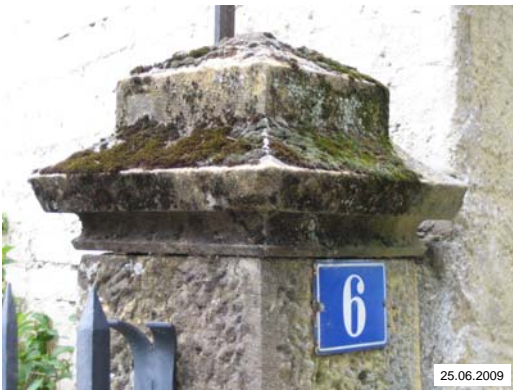
**Algae,  
lichen,  
mosses**

Neuchâtel  
Rue de  
la Main  
(CH, NE)  
limestone

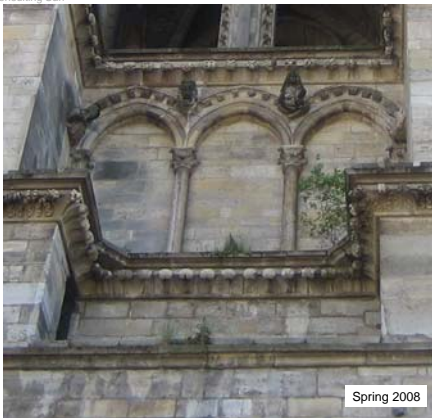
Plants  
(grass and shrubs)  
*arbustes*

Reims Cathedral  
(France)  
Limestone

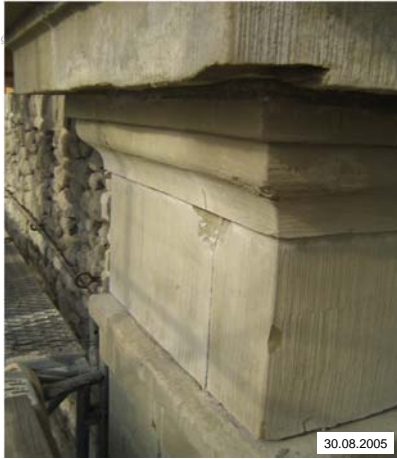
#### Splinter

Montheron Temple  
(CH, VD)  
Burdigalian molasse  
sandstone

- Fragments of variable shapes and forms, separating from masonry, often starting from corners or from the joints of mortar
- Fragments consist of unchanged material
- Can result from damage caused by the use of a too hard mortar, an accident, vandalism,...

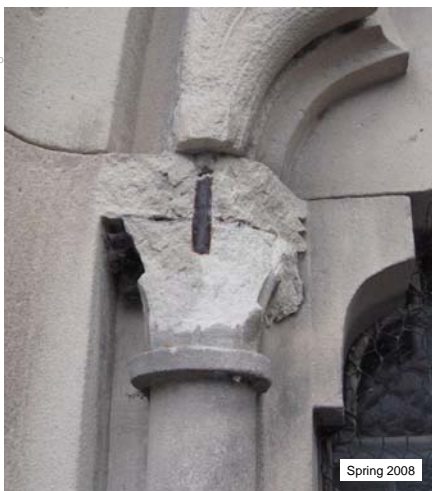
#### Bursting

Epinal Basilica,  
France  
Sandstone

- by the swelling of metal element rust embedded in the masonry
- or
- by the ettringite formation in case of the use of cement to restore a stone or a mortar containing gypsum

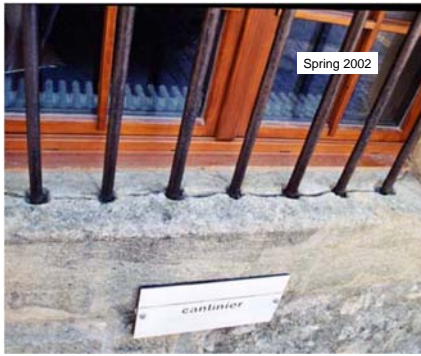
### Bursting

Colombier  
(CH, NE)  
Pierre jaune
