Conservation Science Consulting Sàrl

# Salzverwitterung

Christine Bläuer

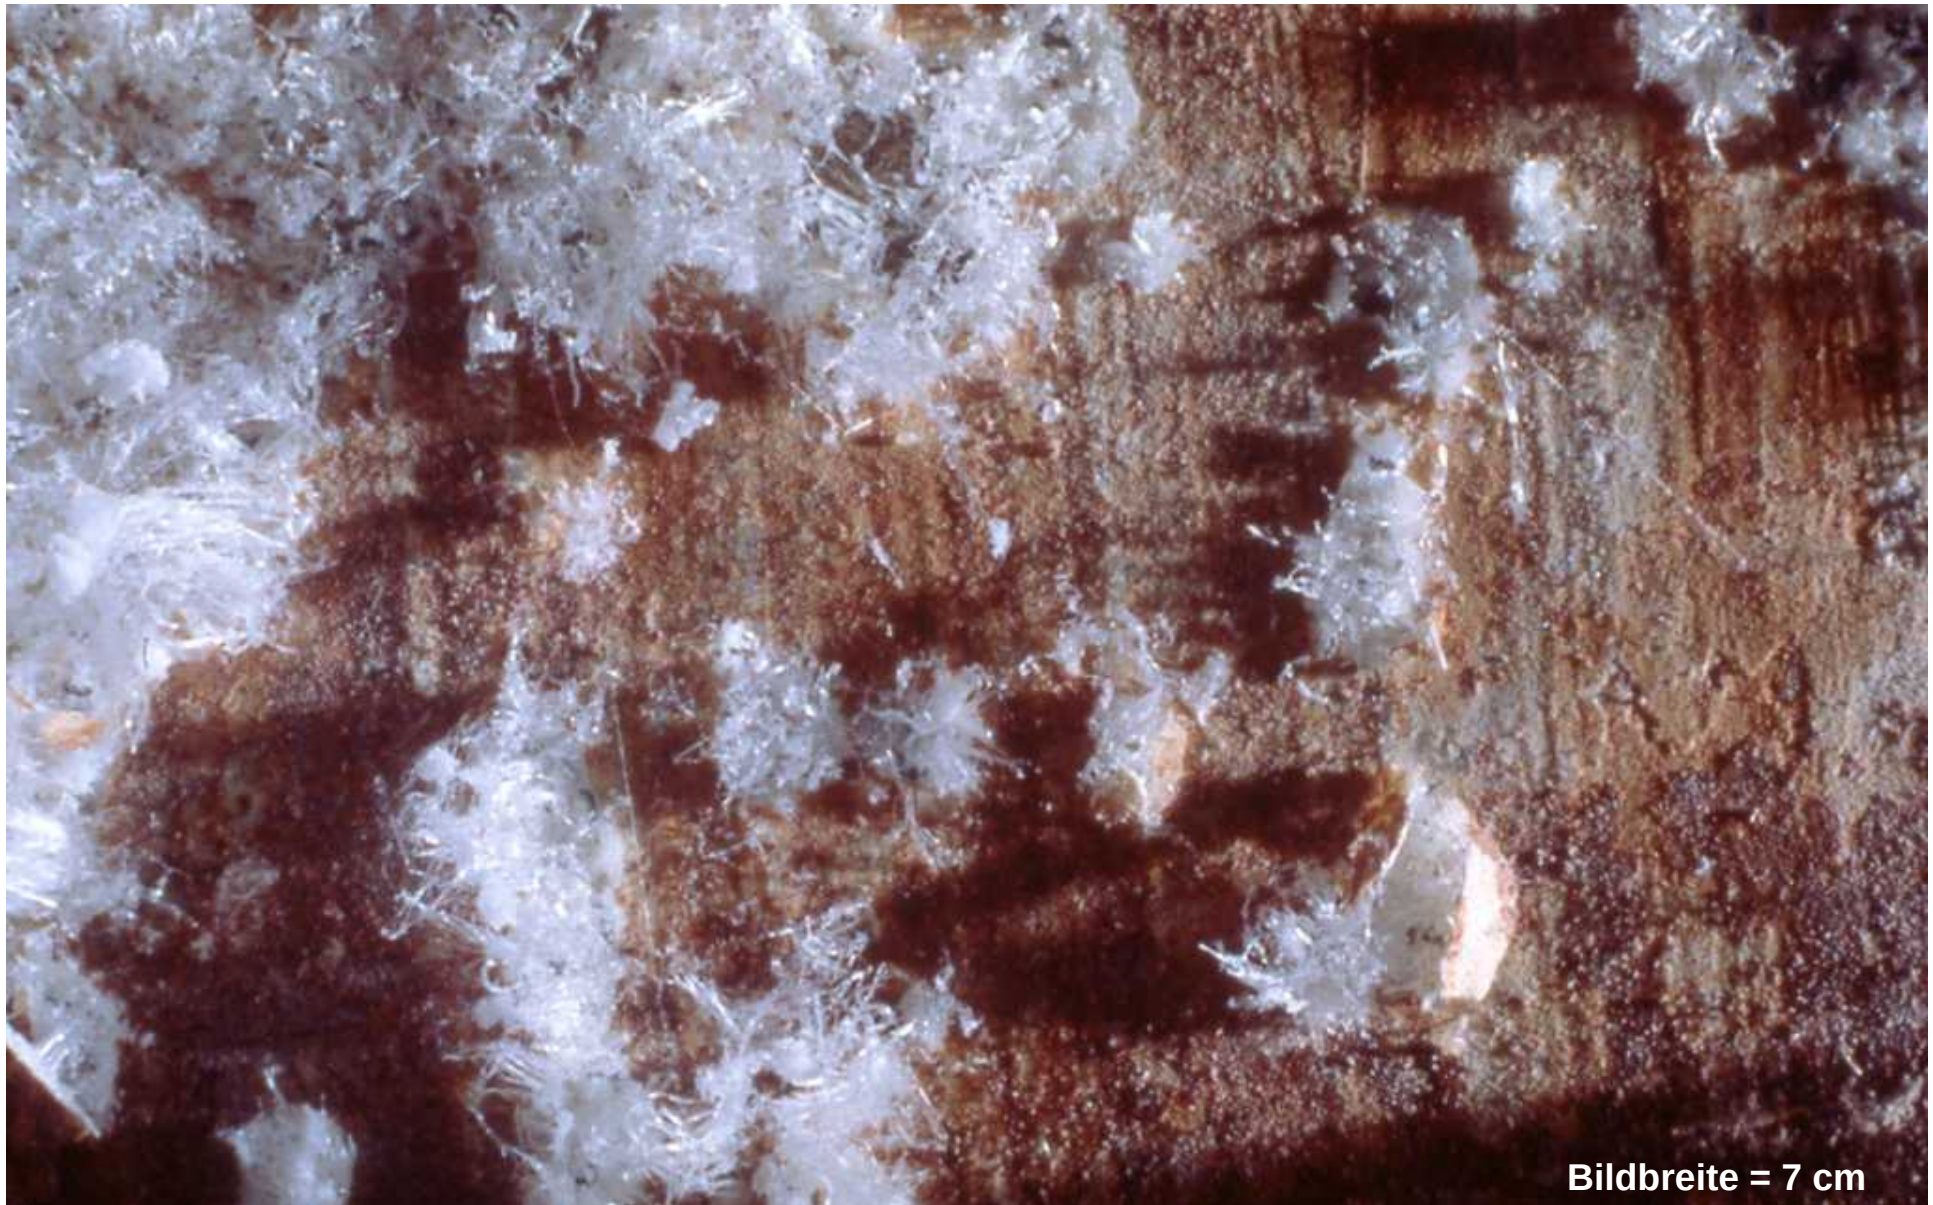
Kirche Lavin GR

Bildbreite = 7 cm

Farbschicht durch Mirabilit ( $\text{Na}_2\text{SO}_4 \cdot 10\text{H}_2\text{O}$ ) abgestossen

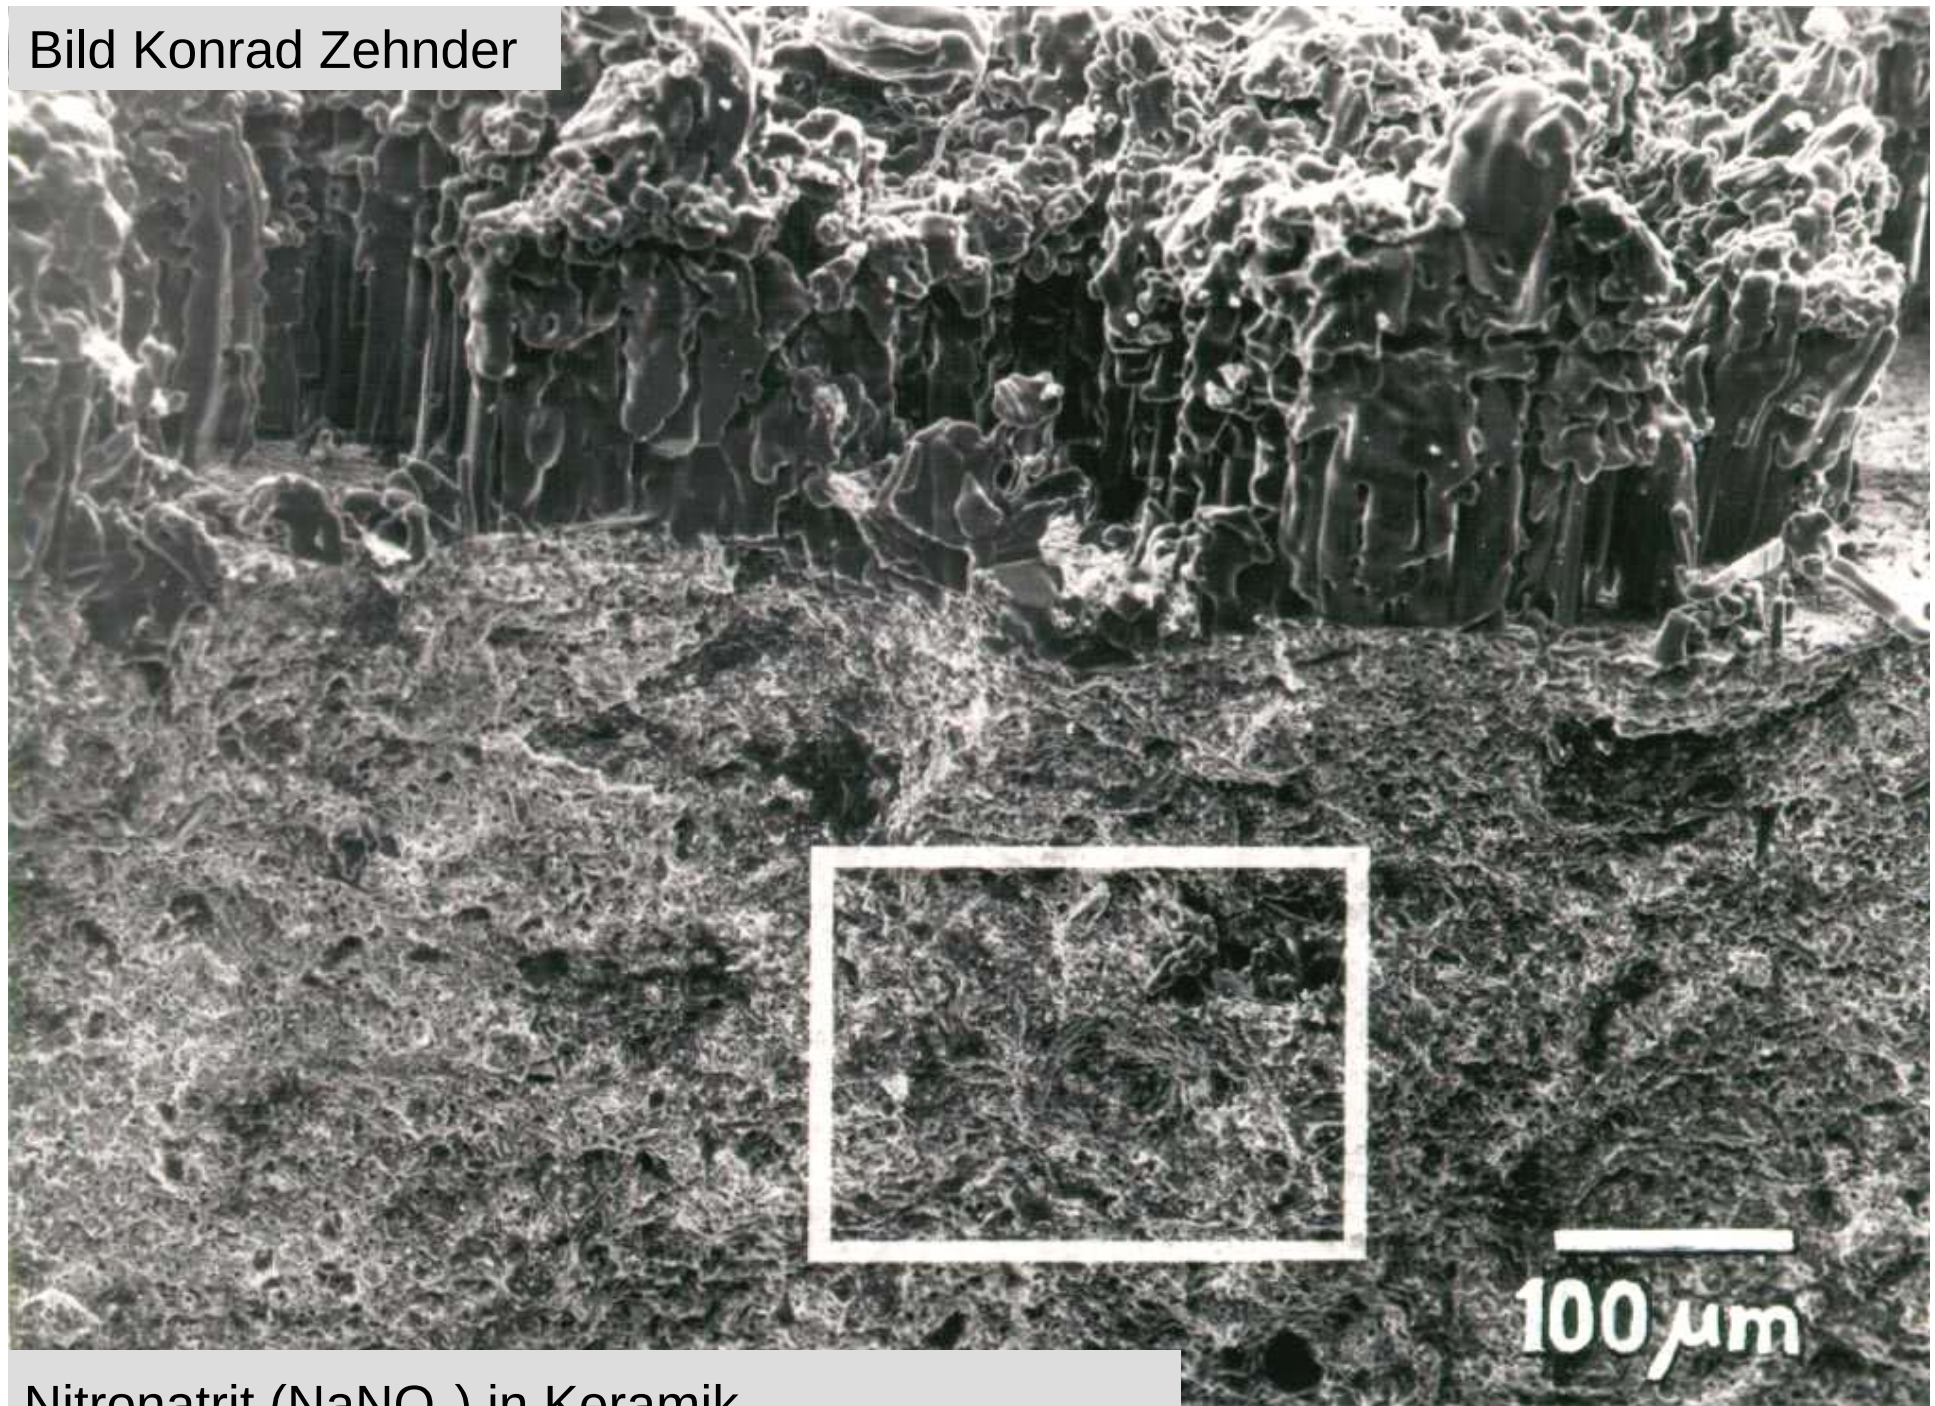
Nitronatriit ( $\text{NaNO}_3$ ) in Keramik

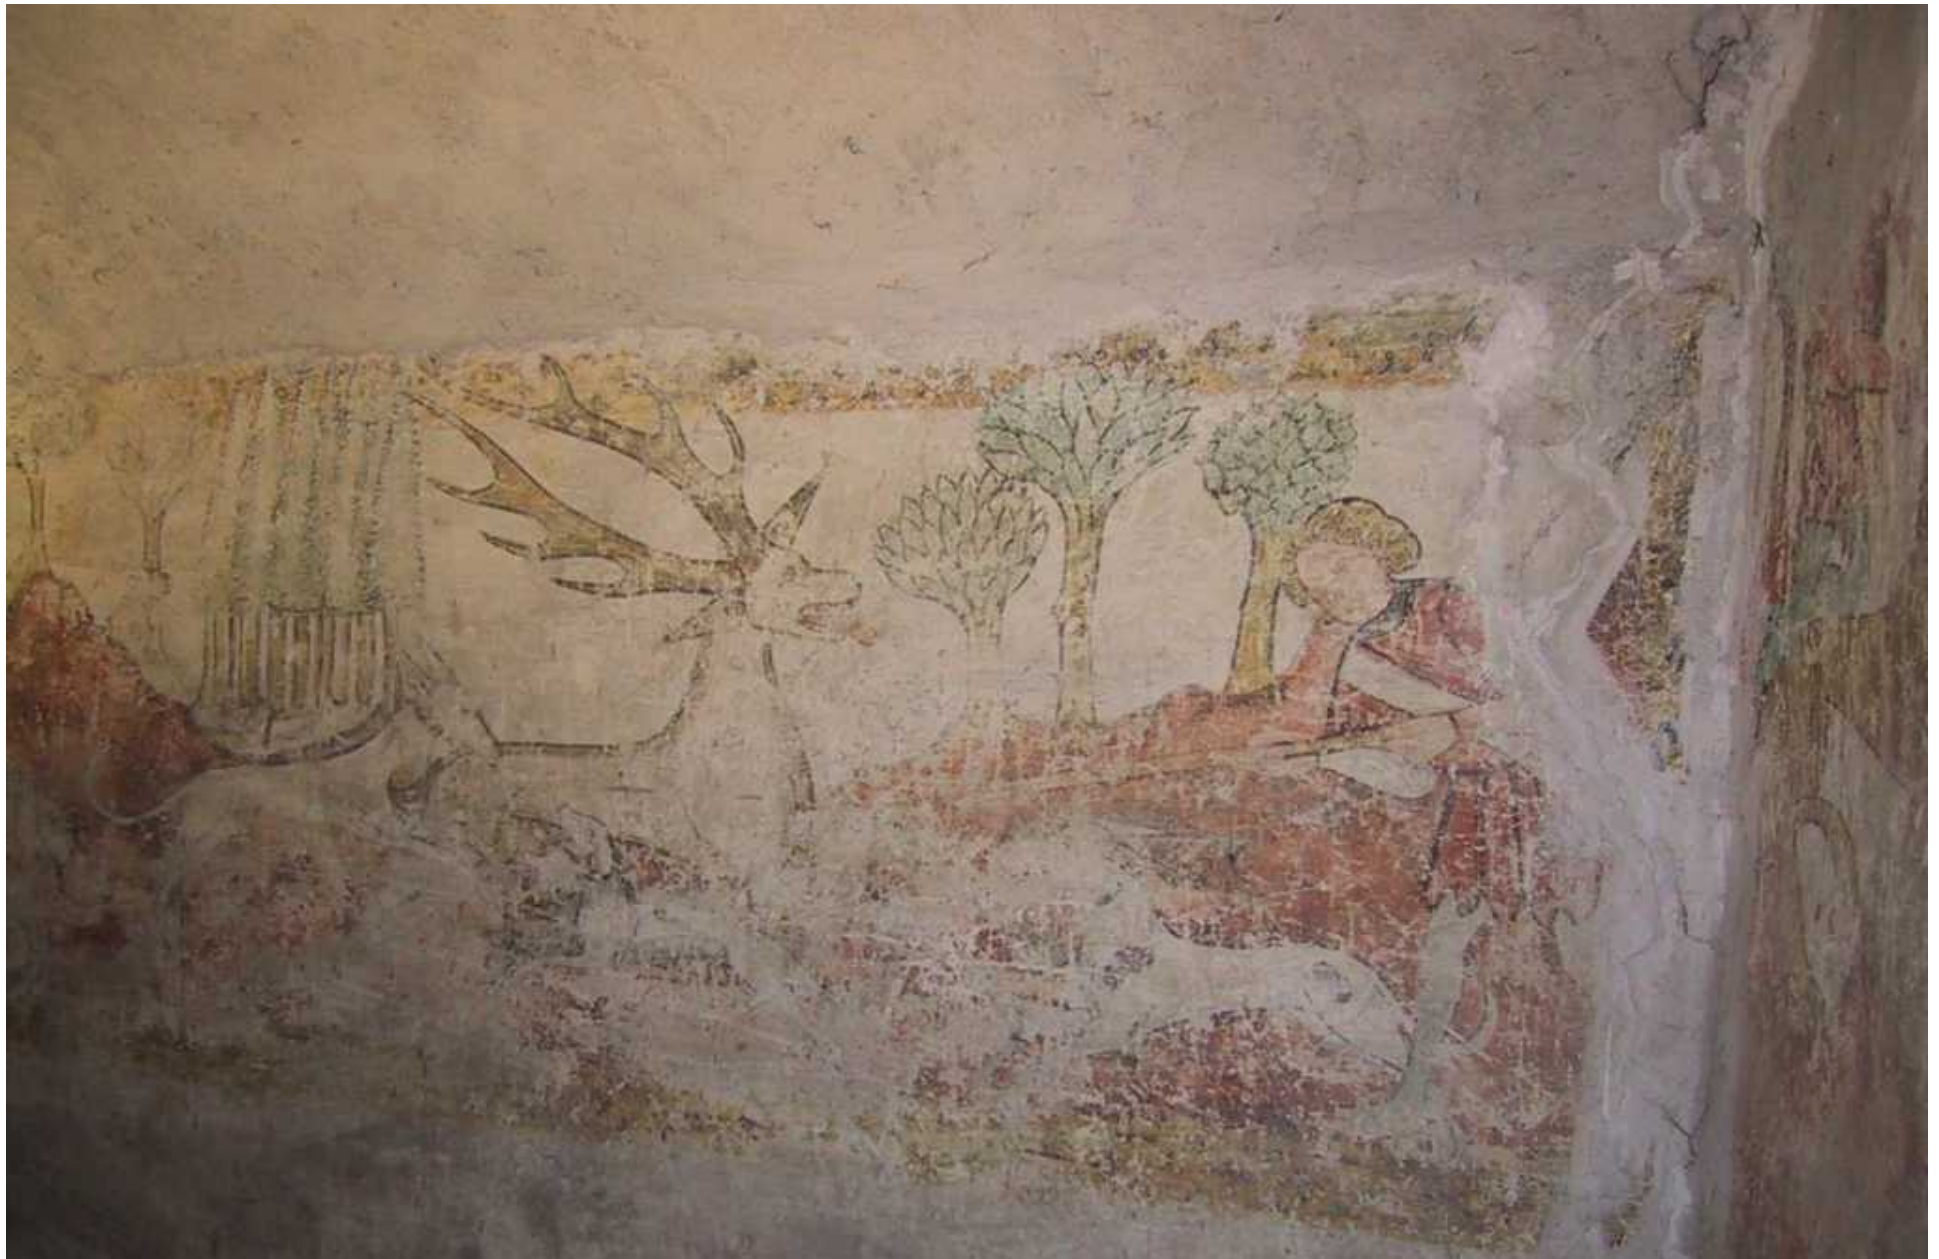
Stoffelhaus, Fürstenau, GR  
Wandmalerei um 1400 mit Jagdszene

mm-thick Salzkruste am  
Gewölbe

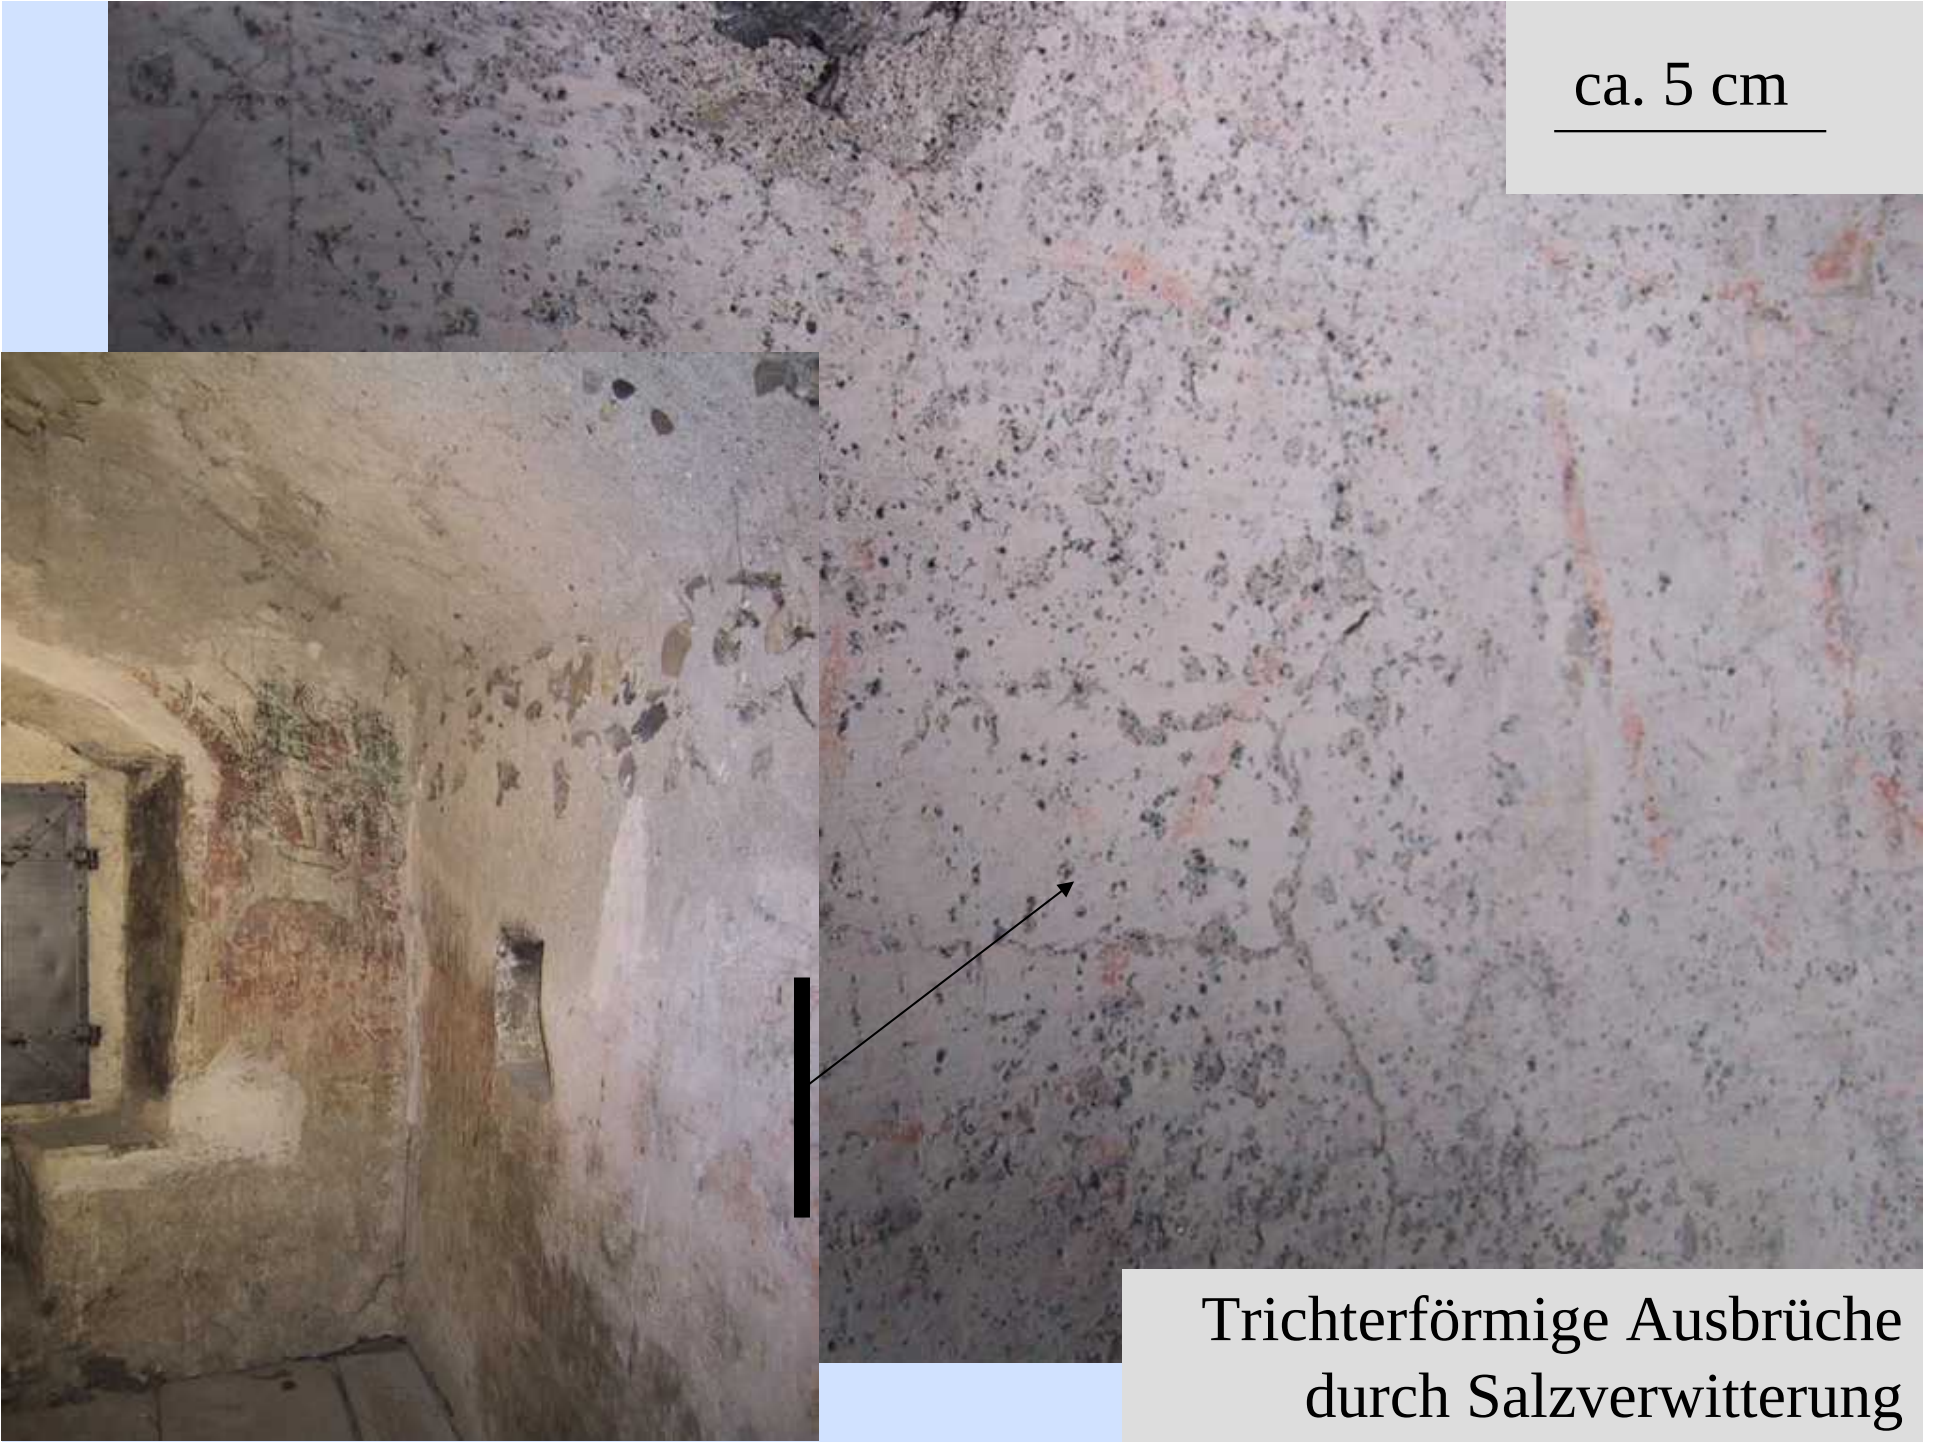
ca. 5 cm

Trichterförmige Ausbrüche  
durch Salzverwitterung
